Report to Tabitha Manderson, WSP, on soil drainage at the proposed Ratana effluent disposal site.

Alan Palmer 2/07/2023

Landscape and Soil Services

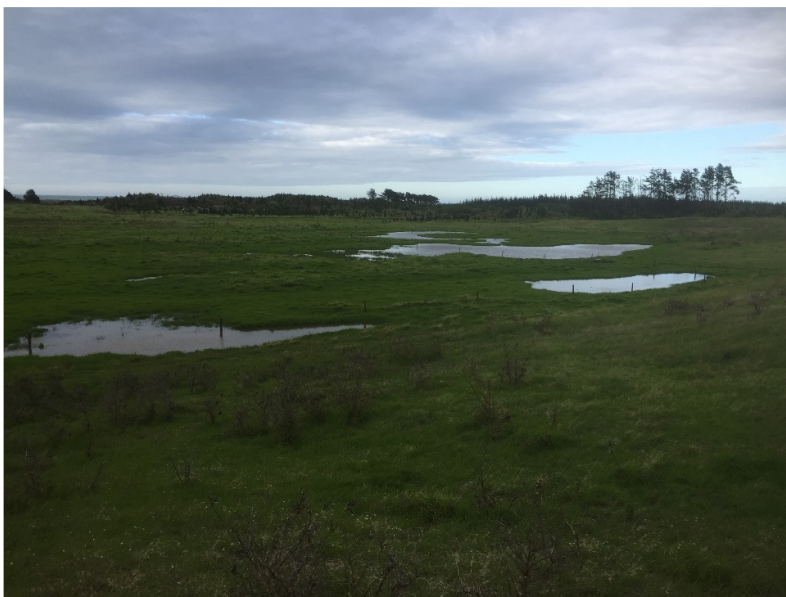
Fig 1. View south from near entrance to the block (17/2/2023). The water-table was also above the ground surface in several of the areas of pasture. Small differences in elevation dictate the drainage status of the soil.
